## Performance of Masonry Buildings during the February, 2017 Ayvacık (Çanakkale) Earthquakes

### Abstract

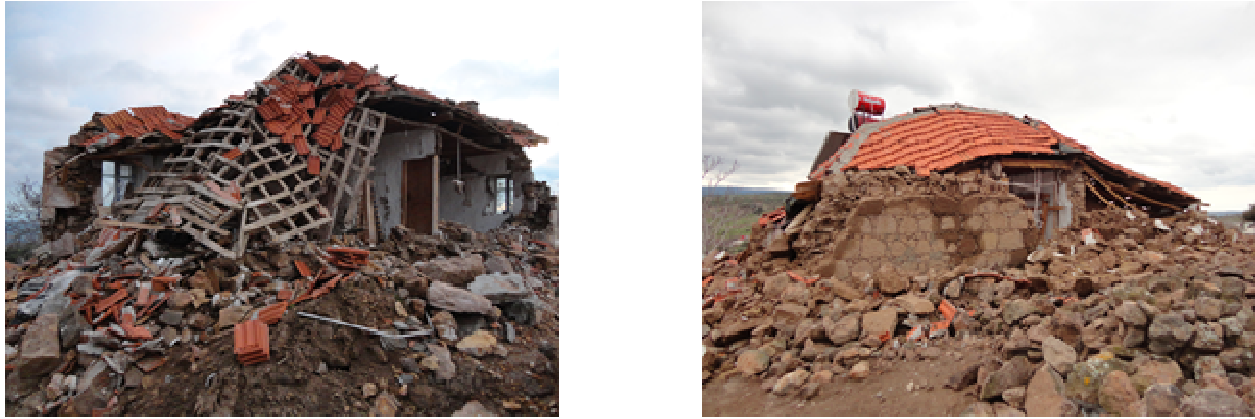
The February, 2017 Ayvacık (Çanakkale) earthquakes caused significant damage to Ayvacık and its vicinity. The five earthquakes hit the buildings within a week. A large proportion of the nonengineered stone masonry buildings completely collapsed or heavily damaged as shown in Figs. 3 and 4.

**Figure 3.** Examples of completely collapsed masonry buildings

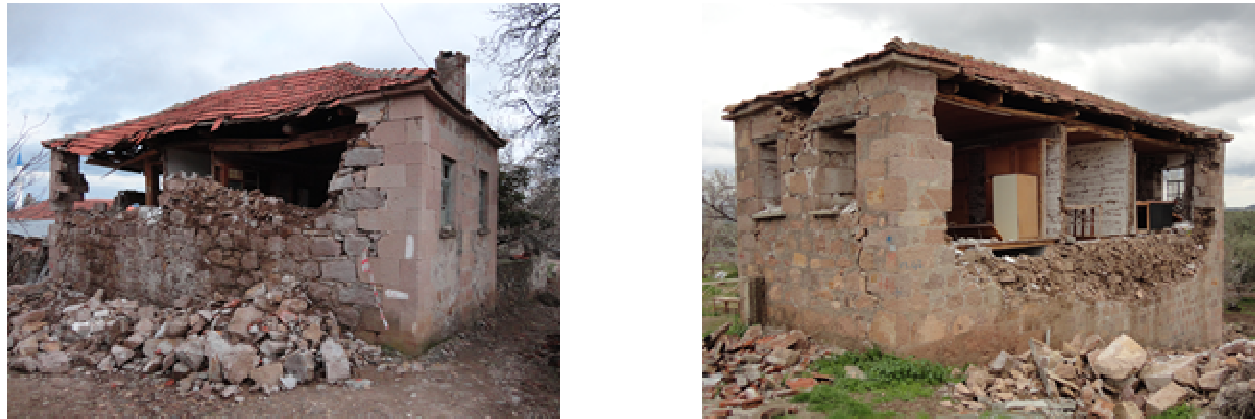
**Figure 4.** Examples of heavily damaged masonry buildings

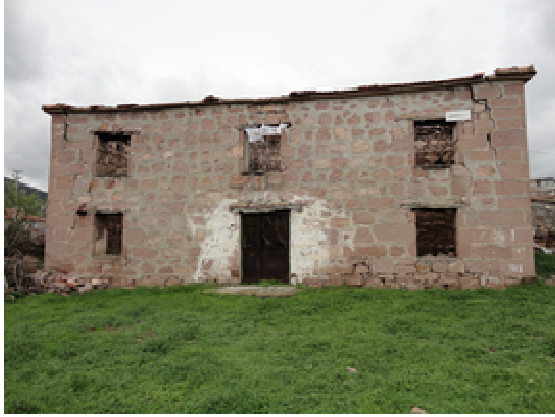
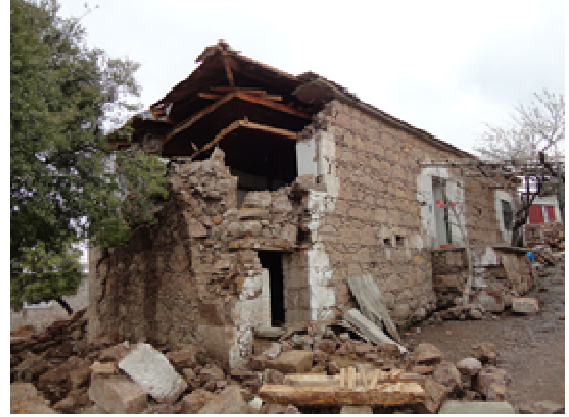
According to the Turkish Earthquake Code [10], natural stone load-bearing walls shall be used only in the basement and ground stories of masonry buildings. There were several two-storey stone masonry buildings in the affected area. Most of these buildings heavily damaged as displayed in Fig. 5.

**Figure 5.** Examples of heavily damaged two-storey stone masonry buildings

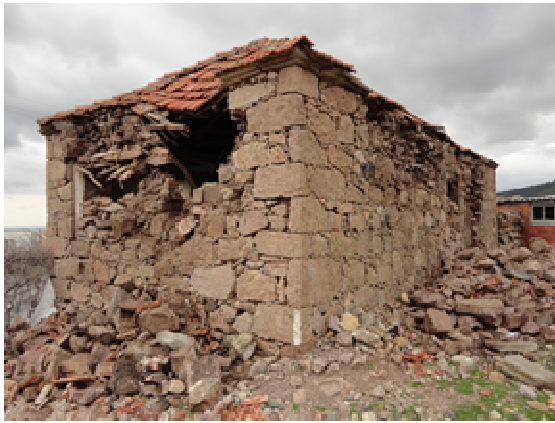
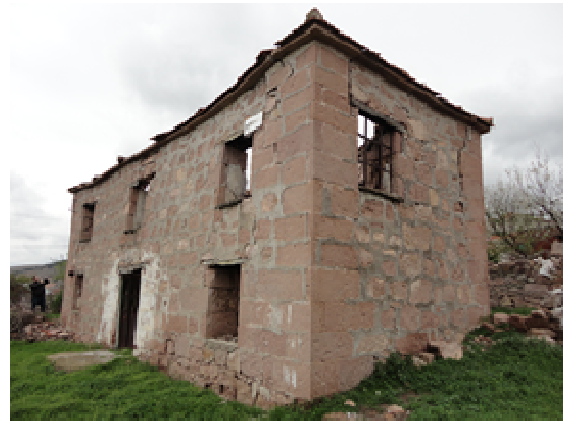
According to the Turkish Earthquake Code [10], the ratio of the total length of masonry load-bearing walls in each of the orthogonal directions in plan (excluding window and door openings), to gross floor area (excluding cantilever floors) shall not be less than  $(0.20I) \text{ m/m}^2$  where  $I$ , represents building importance factor.  $l_a/A \geq 0.20I \text{ m/m}^2$ , where  $l_a$  is length of hatched area (m),  $A$  is gross floor area ( $\text{m}^2$ ) and  $I$  is building importance factor.  $I=1.0$  for residential buildings. There were many stone masonry buildings where this condition was not provided in the affected area. Most of these buildings damaged in the earthquakes as shown in Fig. 6.

**Figure 6.** Examples of stone masonry buildings with inadequate load-bearing walls in each of the orthogonal directions in plan

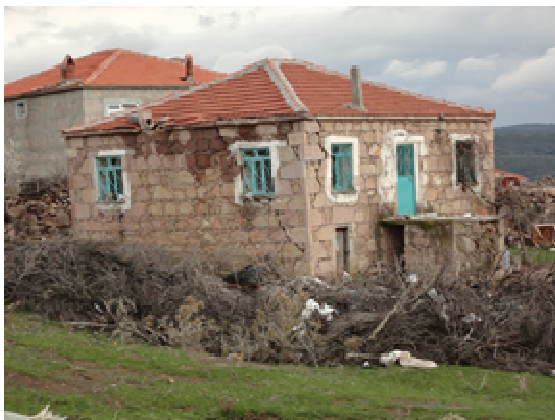
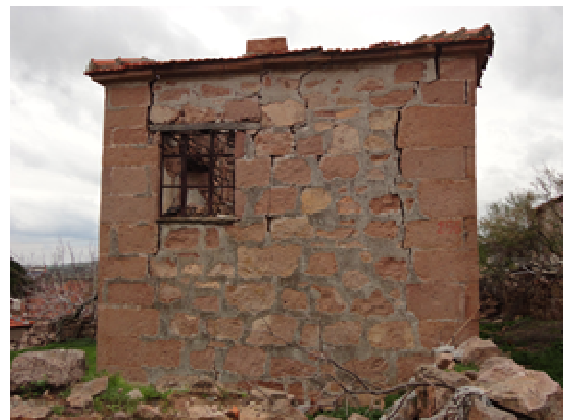
According to the Turkish Earthquake Code [10], plan length of the solid wall segment to be set between the corner of a building and the nearest window or door opening to the corner shall not be less than 1.50 m in the first and second seismic zones. There were several stone masonry buildings where this condition was not provided in the affected area. Most of these buildings damaged in the earthquakes as demonstrated in Fig. 7.

**Figure 7.** Examples of masonry buildings which the nearest window or door opening to the corner was less than 1.50m

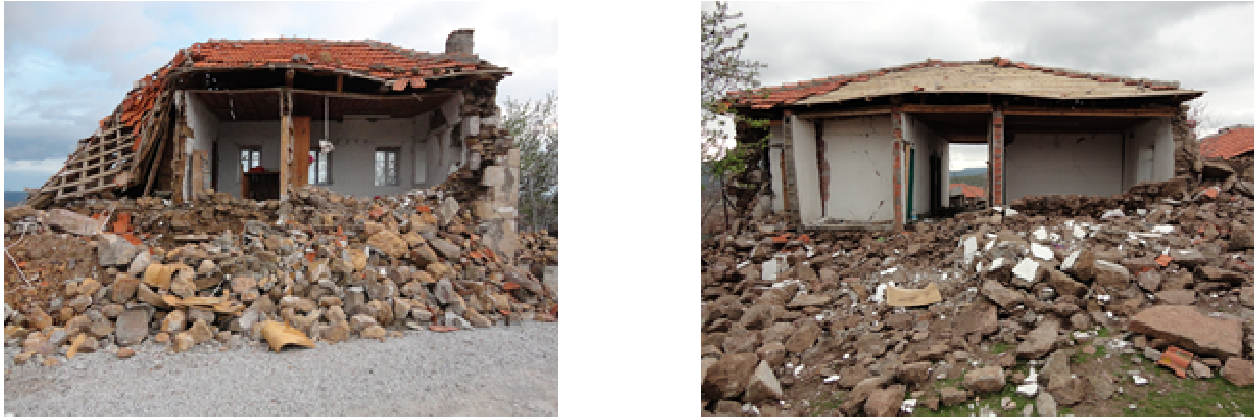
According to the Turkish Earthquake Code [10], unsupported length of any load-bearing wall between the load-bearing wall axes in the perpendicular direction in plan shall not exceed 5.50 m in the first seismic zone. There were many masonry buildings whose outer walls were stone and the inner walls were brick or wood in the area affected by the earthquakes. There was not any bond between inner and outer walls of these buildings. The outer walls of these buildings were the load-bearing, while the inner walls are not load-bearing. Therefore, unsupported length of any load-bearing wall between the load-bearing wall axes in the perpendicular direction in plan exceed 5.50 m in the affected area. Many of these buildings heavily damaged in the earthquakes as illustrated in Fig. 8.

**Figure 8.** Examples of masonry buildings whose outer walls were stone and the inner walls were brick or wood

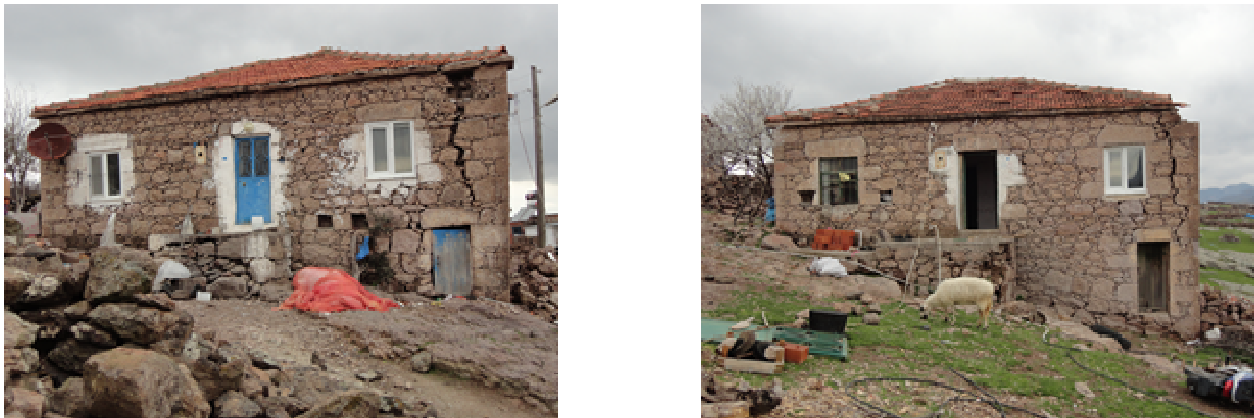
According to the Turkish Earthquake Code [10], construction of partial basement shall be avoided. There were a lot of masonry buildings with partial basements in the affected area. Many of these buildings broken in the earthquakes as shown in Fig. 9.

**Figure 9.** Examples of masonry buildings with partial basements

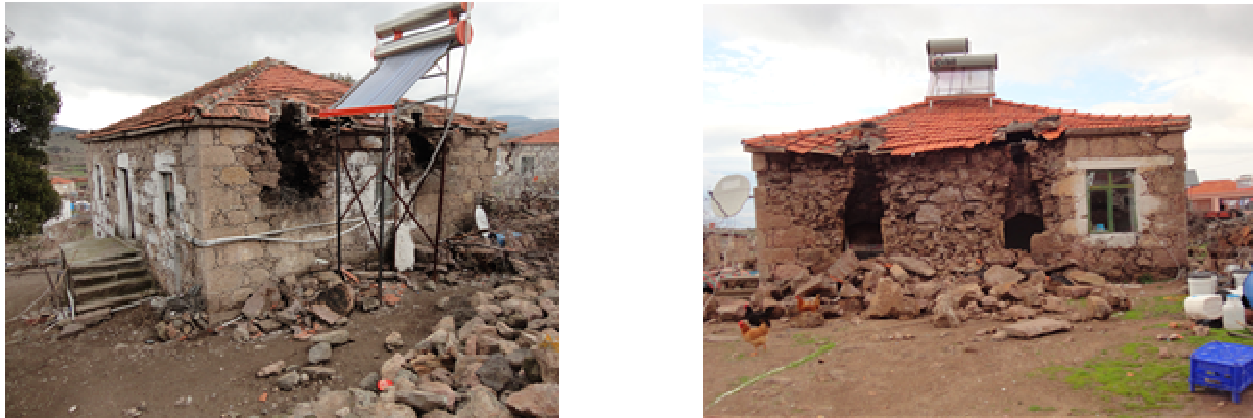
According to the Turkish Earthquake Code [10], minimum thicknesses of the load-bearing walls of natural stone masonry buildings shall not be less than 50cm. The wall thickness was reduced during construction of fireplace in masonry buildings in the affected area. Most of these buildings damaged in the earthquakes as displayed in Fig. 10.

**Figure 10.** Examples of masonry buildings whose wall thickness was reduced during construction of fireplaces

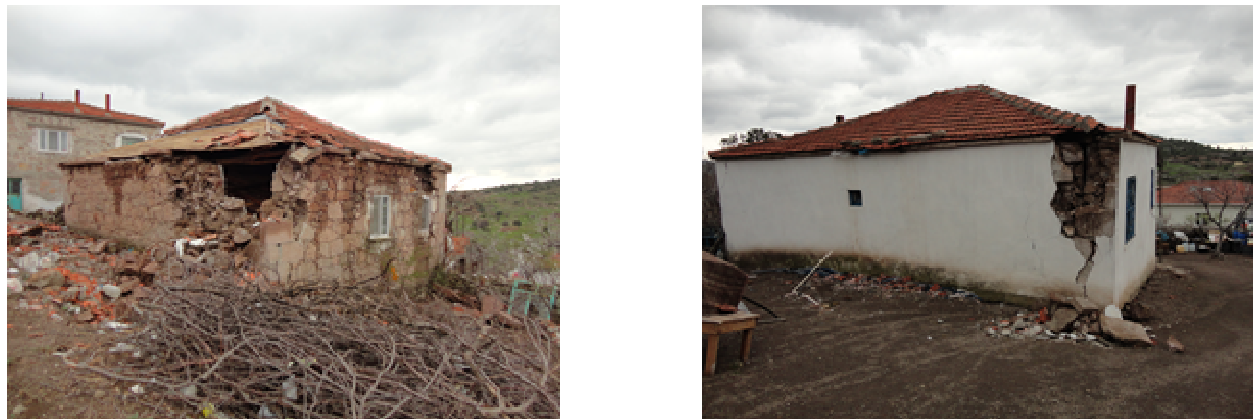
The corners were seriously cracked and the stones collapsed in the affected area. Fig. 11 illustrates the collapse of the building corners. This is owing to the deficiency of connection between orthogonal walls and between walls and floors or roofs.

**Figure 11.** Examples of failure of masonry building corners

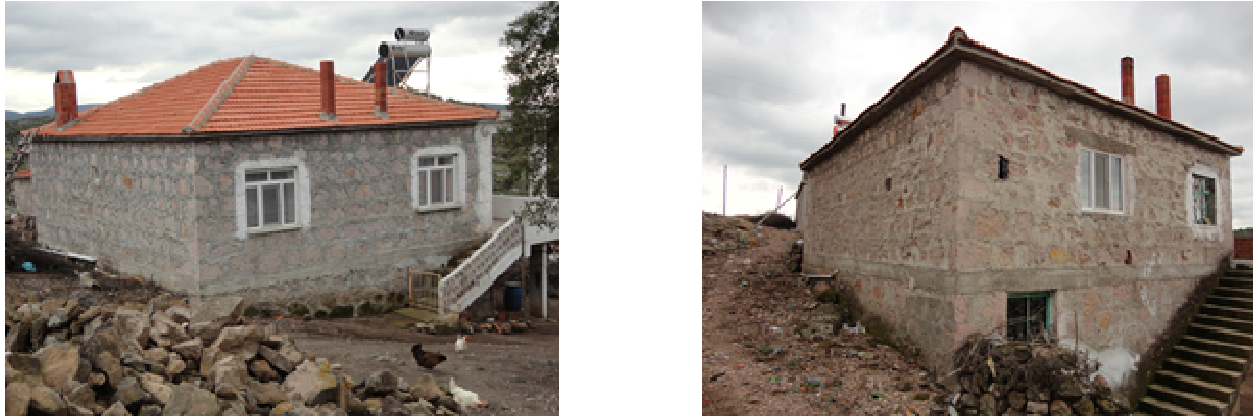
Usually, it is seen that the structural performance of the masonry buildings in the affected area was not adequate during the earthquakes. However, there were also some observations of good performance as given in Fig. 12. This was mainly because of proper care and good workmanship during the construction.

**Figure 12.** Examples of undamaged masonry structures
