# Failures of multi layered infill walls during seismic excitation

<sup>1</sup>Burak Yön and <sup>1\*</sup>Onur Onat <sup>1\*</sup>Munzur University, Civil Engineering Department, Aktuluk Campus, Tunceli, TURKEY

### Abstract:

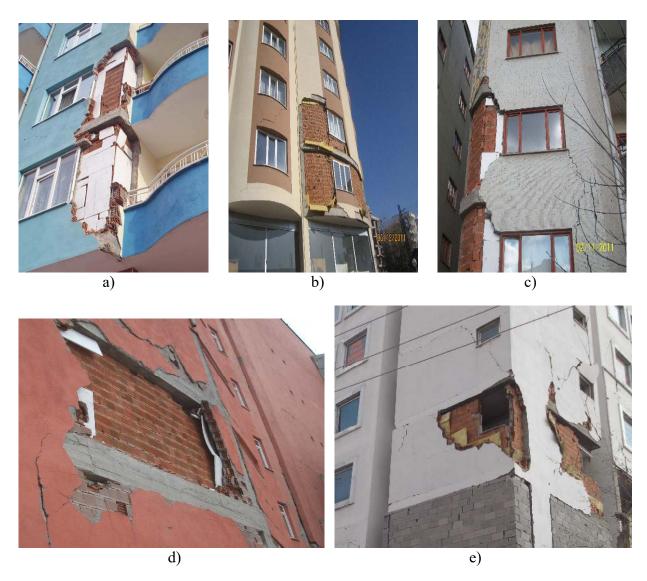
In many reinforced concrete buildings such as residential and office buildings, infill walls have been placed as two layers to increase the thermal insulation in Turkey. Insulation materials such as XPS foam and fiberglass are used between the internal and external layers of infill wall. The external layer is placed partially outside the frame, sometimes on a short-cantilevered slab as seen in Figure 4a, b.

Figure 4. Failures of multi layers infill walls during the Van earthquakes

Furthermore, the external layers are constructed with separately between the storeys. In addition to this, connection of these two layers is not paid attention while designing and constructing. Production of these two layers in one frame poorly connected. This situation causes partially or totally damages. Even though, these type of design increases the seismic vulnerability of outer layer of infill wall, damages of inner layers remain lower level. This type of damages can be seen in Figure 4c-e and Figure 5 for both Van and Bingöl earthquakes, respectively.

• This type of walls was poorly connected to the RC frame, especially the external wall. Then, under peak condition, the response of the wall shows similar behaviour as out-of-plane mechanism.

• For multi layered infill wall, outer layer shows lower performance than inner layer due to poor connection between layers and outer layers showed brittle behaviour.

This type of measures can be achieved by adopting suitable solutions for both in-plane and out-ofplane behaviour. For instance, placing light wire meshes anchored on outer layer of the infill wall. One another solution is using bed joint reinforcement between each two-brick layer.

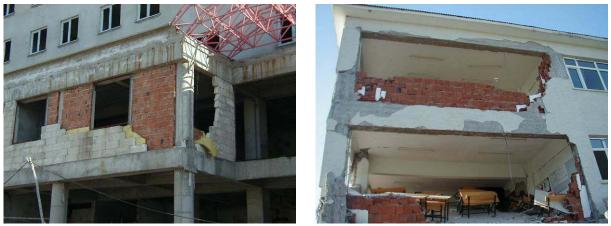
Figure 5. Failures of multi layers infill walls during the Bingöl earthquakes
