Earthquake risk amplification based on architectural plan irregularity

*¹Onur Onat and ¹Burak Yön
¹Munzur University, Civil Engineering Department, Tunceli, TURKEY

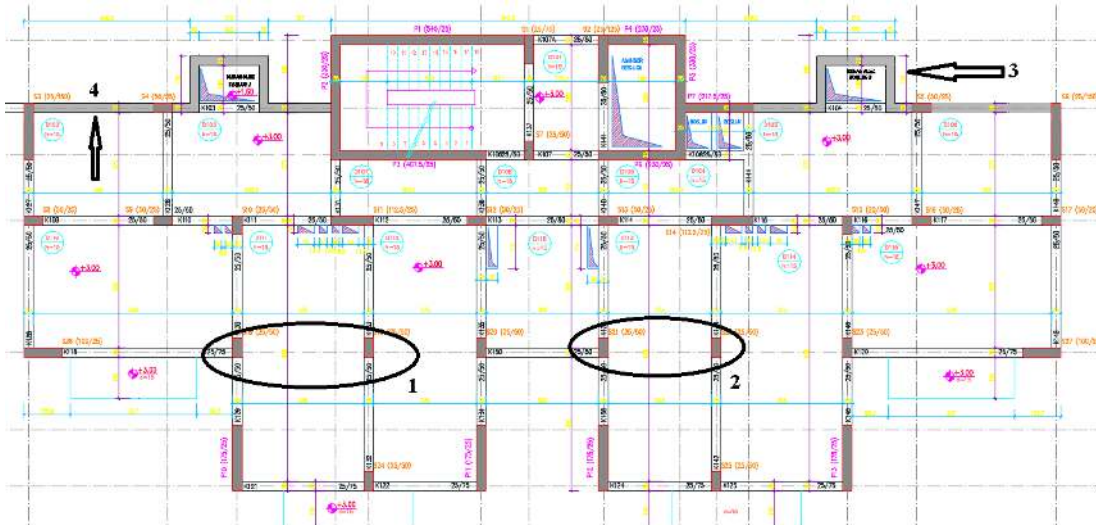
Figure 2. Basement floor plan of Model-I

- First case (Model-I) is the original plan drawn by architectural office as seen in Figure 2,
- Second case (Model-II) is composed of full shear wall at basement floor to overlap center of rigidity and center of gravity.
- Third case (Model-III), in addition to second case, is composed of inserting a beam to indicated span as indicated with the number “1” and “2” in Figure 2.

This selected residential building is under construction in a state university’s campus located in Tunceli province. Plan irregularities and plan geometries of the basement floor of selected building as a Model-I, Model-II and Model-III can be seen in Figure 2, 3 and 4, respectively.

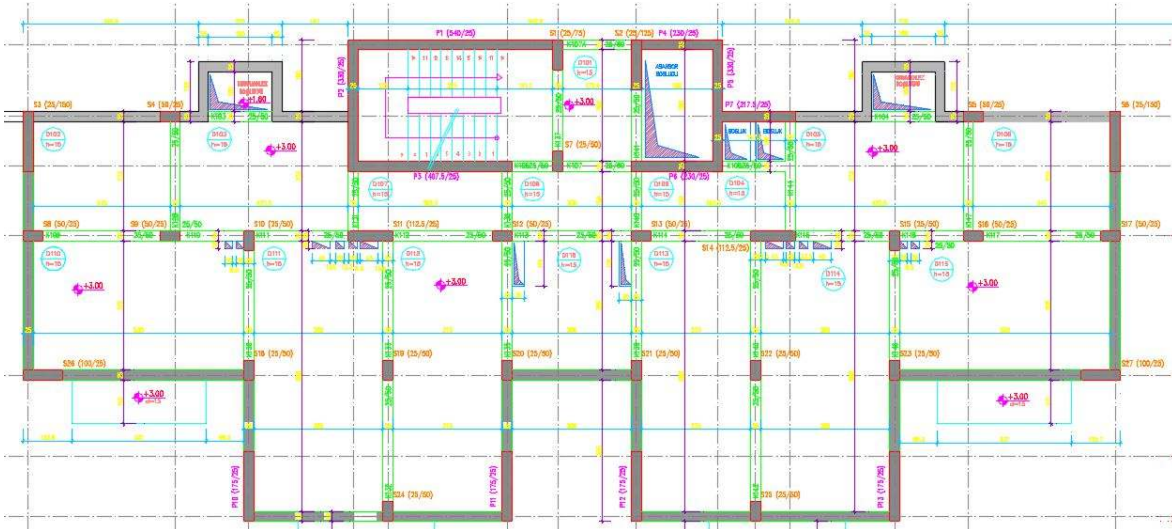
Figure 3. Basement floor plan of Model-II

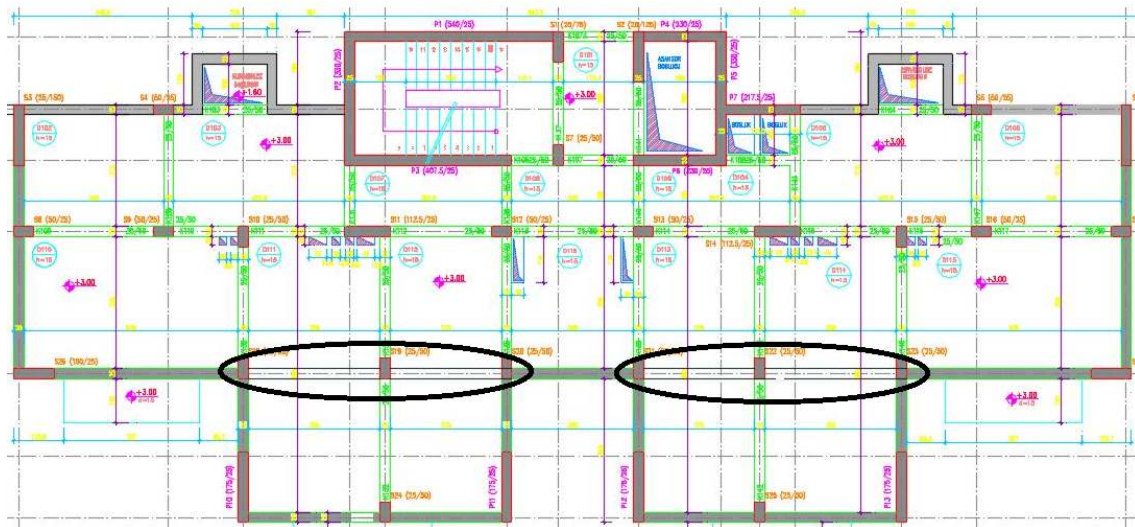
Figure 4. Basement floor plan of Model-III

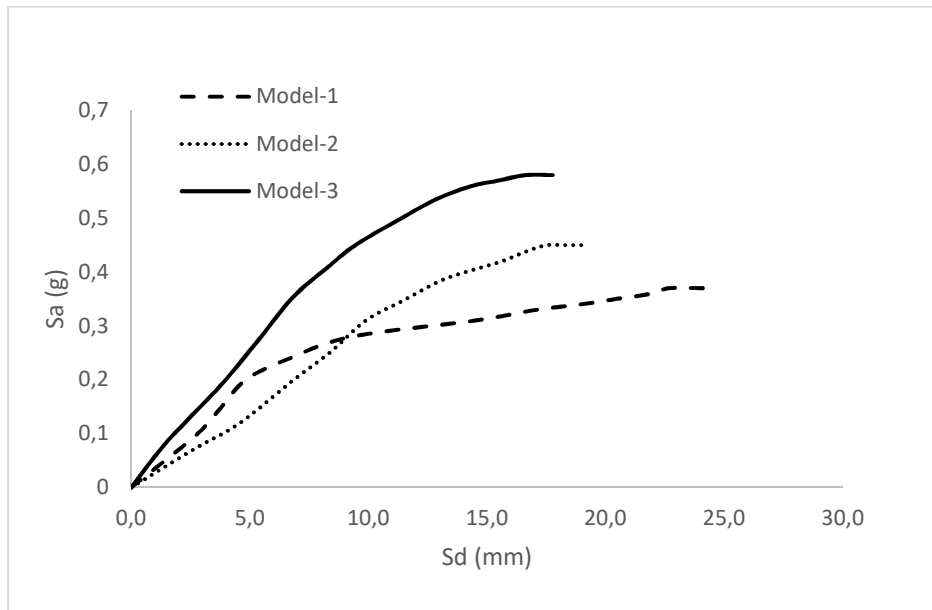
Figure 5. Pushover curve plotted for longitudinal direction

After performing nonlinear static analysis on three models, constructing of shear wall around the perimeter of the building increased the performance of the model as seen in Figure 5 for longitudinal direction. Lateral bearing capacity of the building with original plan geometry was obtained 0.24g spectral acceleration and 24.2 mm spectral displacement. Lateral resistivity of the building in longitudinal direction for Model-II was obtained 0.45g spectral acceleration and 19.04 mm spectral displacement from pushover analysis. 0.58g spectral acceleration was obtained from pushover analysis and 17.76 mm spectral displacement was obtained for Model-III as seen in Figure 5 through longitudinal direction.

As seen from the Figure 5 and Figure 6, eliminating most of the problems increased the lateral bearing capacity of the investigated building. Figure 7 a) and Figure 7 b) presents that constructing shear wall around the building decreased lateral displacement.

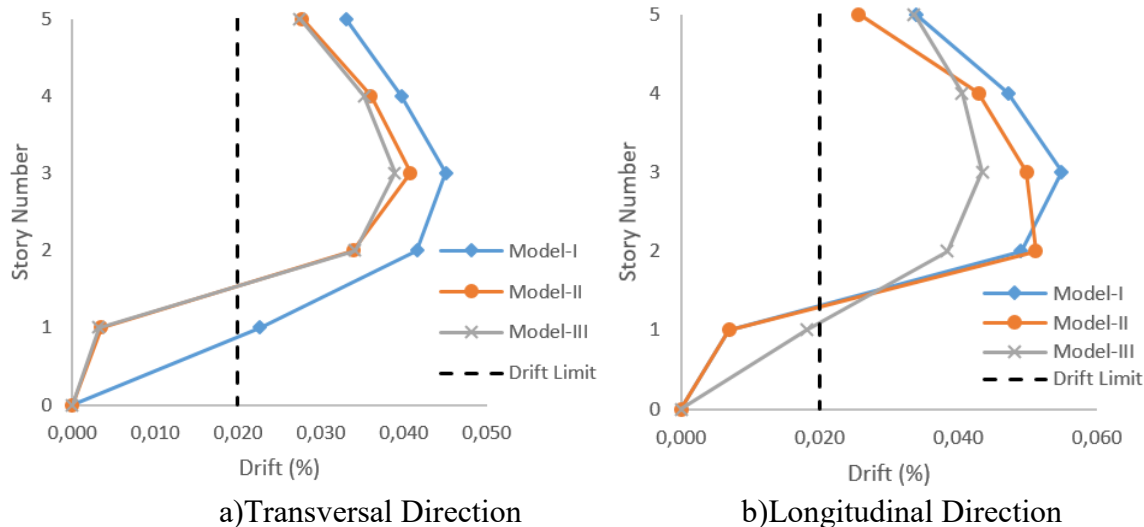
Figure 7. Lateral displacement of numeric model

As seen from Figure 7 a) and b) eliminating problems increased lateral resistivity in both transversal and longitudinal direction. Especially, inserting extra beam to the structural system considerably limited lateral displacements with respect to Model-I and Model-II.
